Seismic Evaluation of Traditional Timber Structures in Taiwan

Tsai, Pin-Hui

A Thesis Submitted for the Degree of Doctor of Philosophy

University of Bath

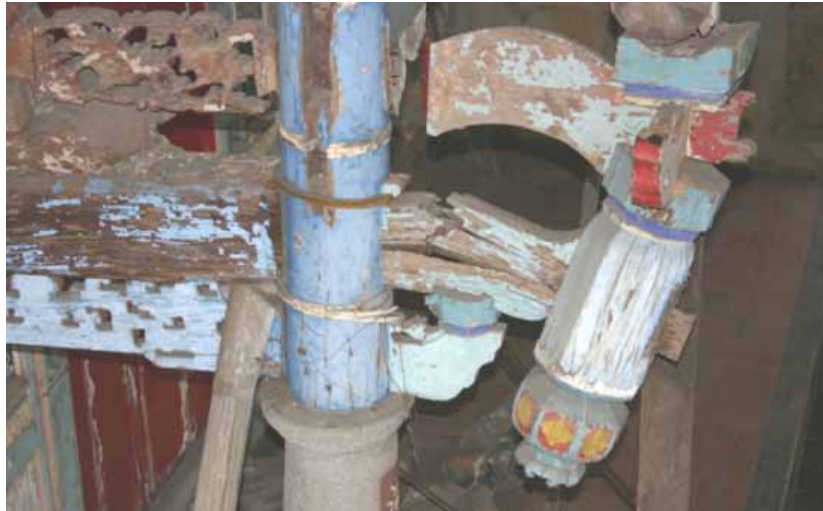
Eave rupture, column sliding and masonry wall cracks are classified as damage level 3. Most of the joint failures mentioned in level 2 come from loss of geometry (i.e. elements moving out irreversibly from their original positions). In some situations, however, they can result in material failure caused by excessive normal, bending and shear force on the pairing element (see Fig. 3.2.9). This type of failure has been observed in the eave part of Dieh-Dou building only. The beam elements of the eave are inserted one side into the corridor column, whilst the other side is hanging. Under an earthquake, these cantilever beams can rupture once the moment and shear overcome the material strength, causing localised collapse of this portion of the roof.

Figure 3.2.9 Eave rupture failure

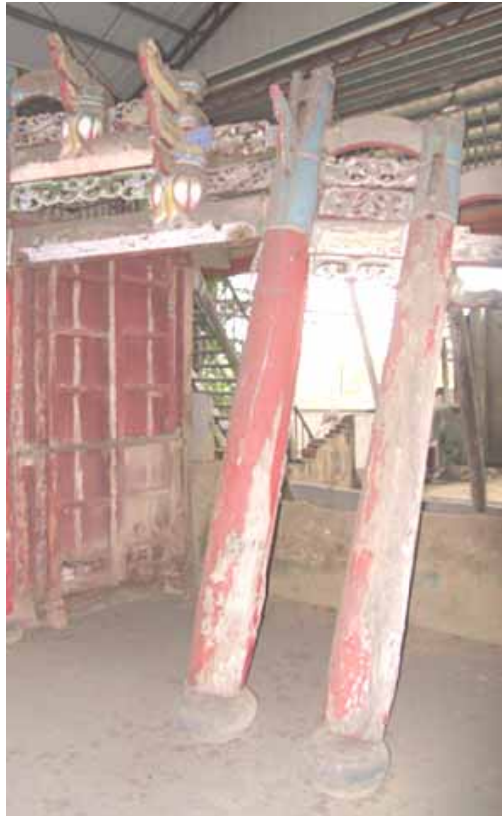
Figure 3.2.12 Columns rotated

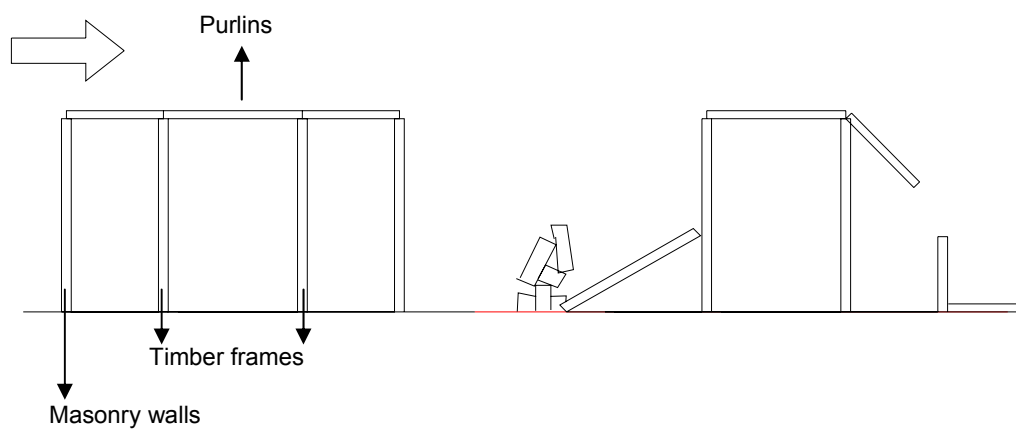
Figure 3.2.13 Failure of purlins under lateral force (out of plane)

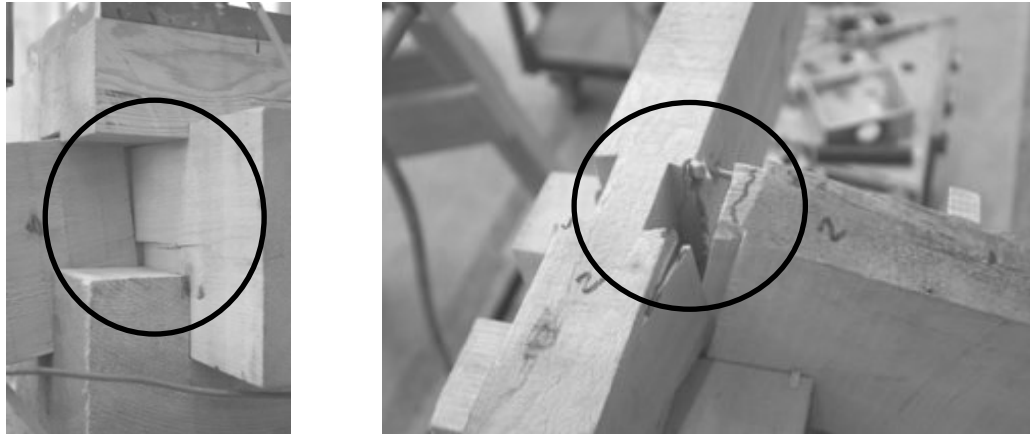
The failure of dove-tail joint developed mostly on Part 6 (Fig.4.3.10). As the construction details of the joint set show, the upper and lower parts of the out of plane beam (Part 6) are restrained by the upper and lower Dou, whereas the middle part is not in contact with any timber element so this area becomes a zone weaker than the other parts in terms of pull-out resistance.

Figure 4.3.10 Failure of Dove tail joint

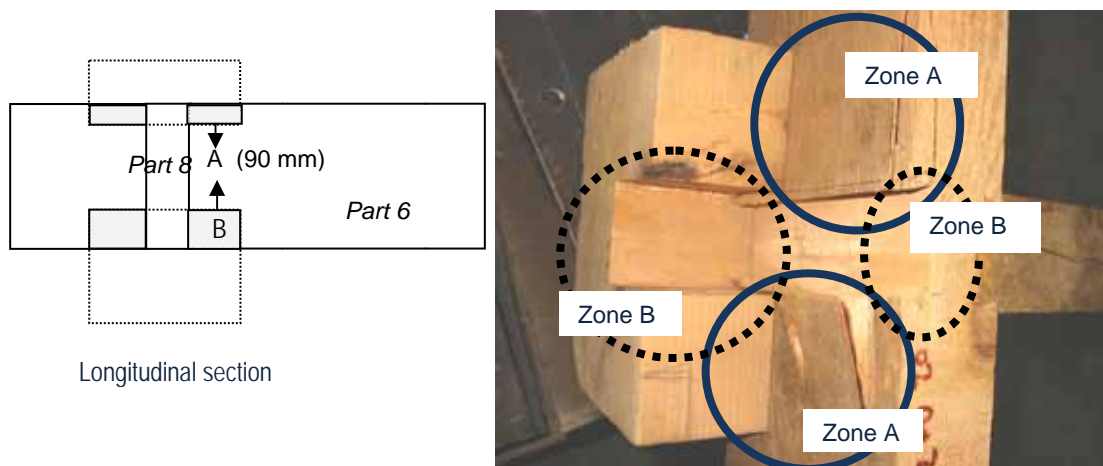
The failure modes of the four tests PO01 to PO04 were very similar. As can be seen from Figure 4.4.4 (left), the areas B of the out of plane beam (Part 6) were initially restrained by the upper and lower Dou, Part 5 and Part 9. When Part 8 starts pulling out, the unconfined area of Part 6 (A in Figure 4.4.1 and 4.4.4) started to crack and deflect. Once timber strength was overcome the areas A ruptured and Part 8 pulled out completely from the joint (see Figure 4.4.5).

Figure 4.4.4 Pull out rupture of joint

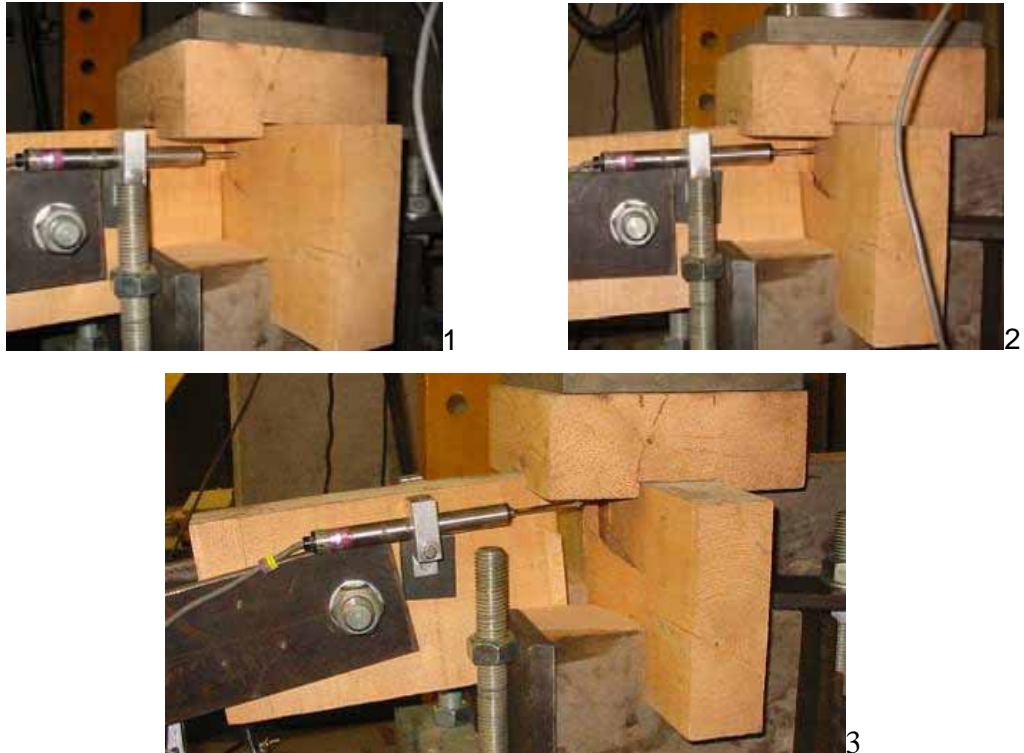
Figure 4.4.5 Sequence of beam pulling out and progressive failure of Part 6

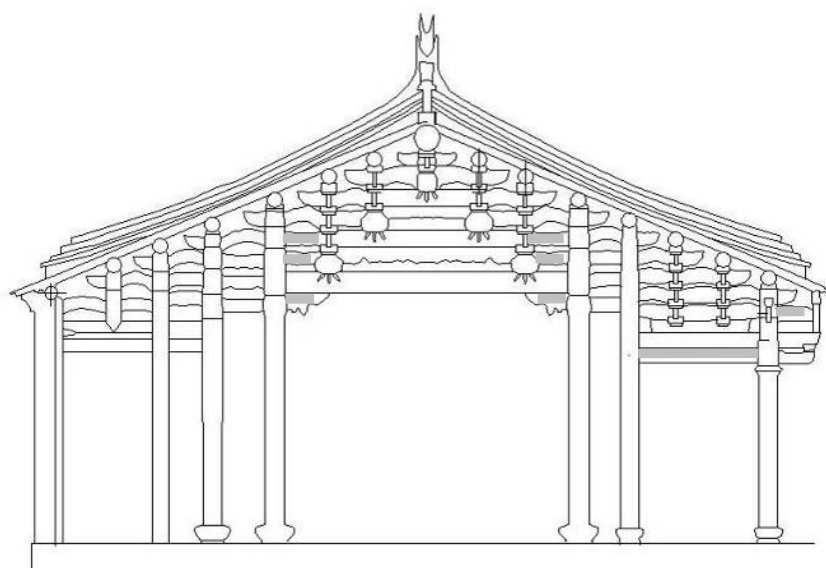
Figure 6.5.2 Damaged elements of Dou-Shan main hall timber left frame

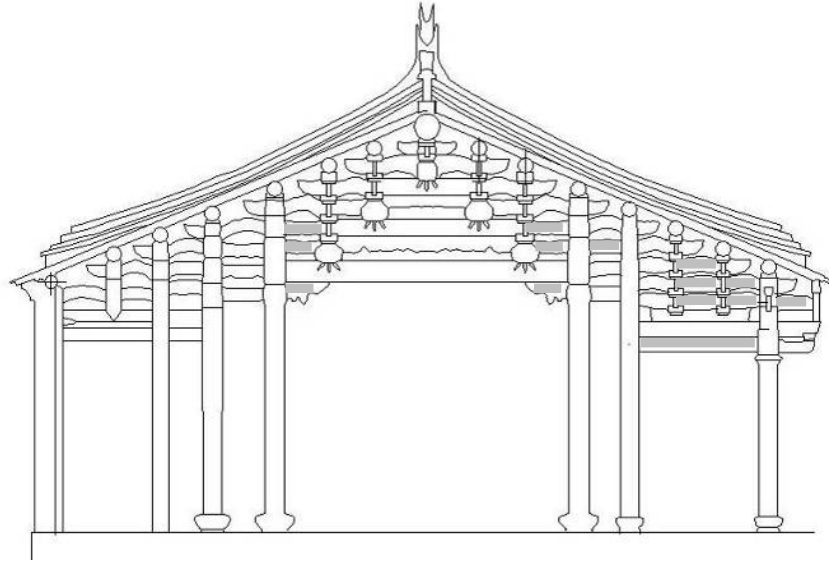
Figure 6.5.3 Damaged elements of Dou-Shan main hall right timber frame

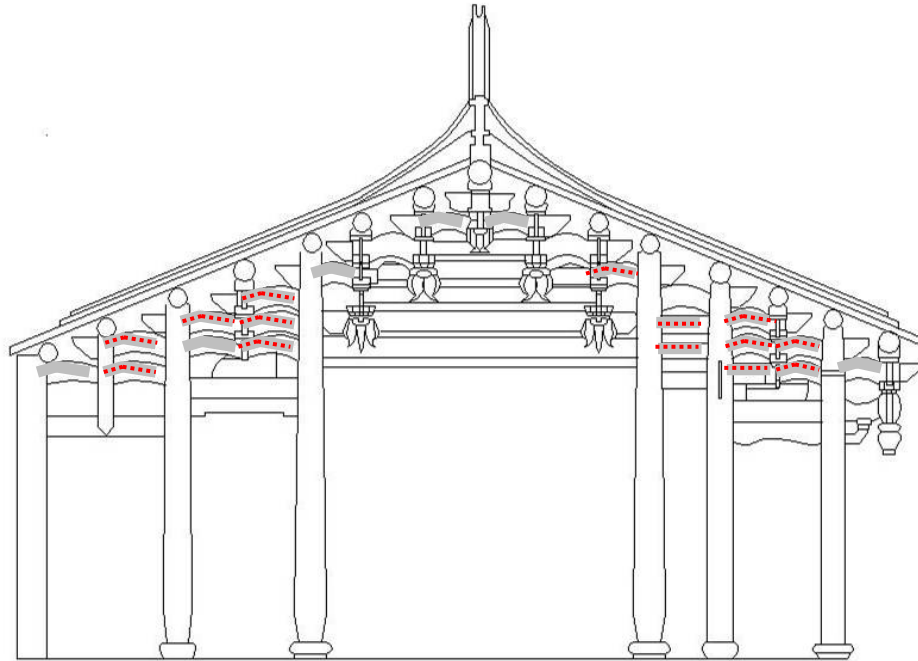
Figure 6.6.2 Failure of Guan-Shi main hall (right frame) and step by step prediction
